FIREFIGHTER & OCCUPANT SAFETY CONSIDERATIONS WITH “MODERN” LIGHTWEIGHT CONSTRUCTION.

Minnesota Governor’s Council on Fire Prevention and Control
November 24, 2010

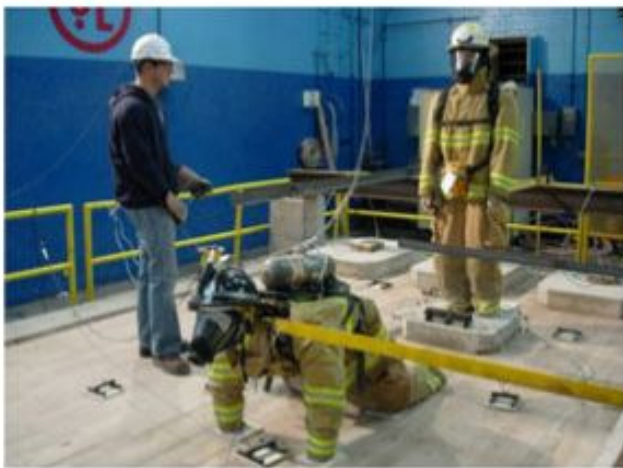
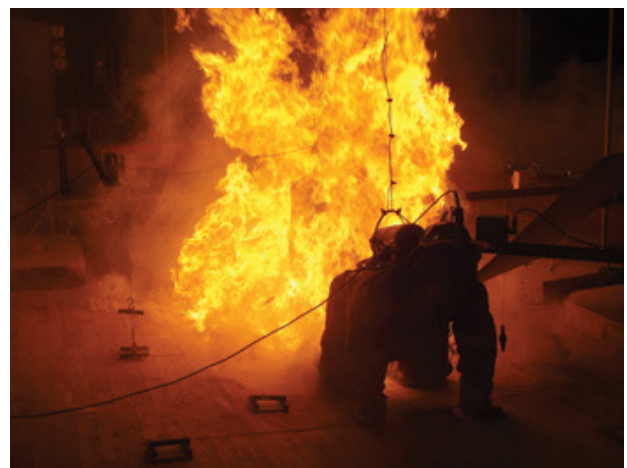
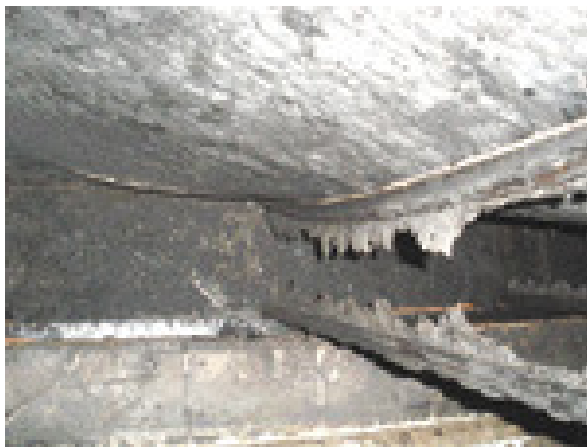
It is important to note the performance of the unprotected lightweight engineered I-joist assemblies compared with other assemblies.

Test results demonstrated that unprotected traditional sawn 2 × 10 lumber construction began to collapse approximately 18 minutes and 30 seconds after ignition. The unprotected engineered lightweight I-joist assembly showed a wide area failure at the 6-minute mark--a marked difference in performance.

(Photos courtesy of Underwriters Laboratories)

• **Floor collapse can occur in 6 minutes.** Engineered wood floor assemblies have the potential to collapse very quickly under well-ventilated fire conditions. When it comes to lightweight construction, there's no margin of safety. There's less wood to burn, and therefore less time before the assembly fails. During this research, the shortest failure time was noted during the unfinished/unprotected engineered wooden I-joint test that experienced a total structural collapse at 6 minutes.

Although the results of the Tyco demonstrations and the UL tests seem to be different, if we factor in the time to flashover in the Tyco demonstrations, they are almost identical to the furnace-controlled post-flashover tests at UL.

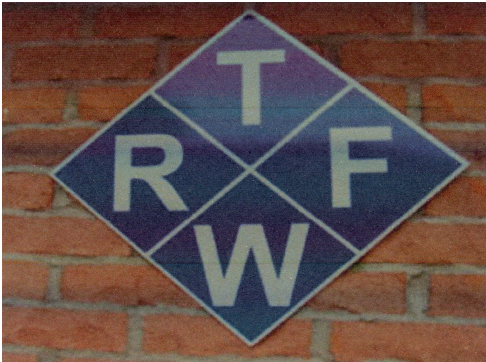
Blue Diamond signs outside buildings alert firefighters to potential dangers on arrival.

The Blue Diamond is designed with four quadrants, similar to the NFPA 704 Diamond. The all-weather reflective diamond is Safety Blue in color and measures 14 x 14 inches square. The top quadrant contains the letter **T** which denotes the presence of truss construction. The lower left quadrant contains the letter **R** if truss construction is used in the roof system. The quadrant to the right contains the letter **F** if the structure has floor trusses present. If floor trusses are not present, the quadrant is left blank. The bottom quadrant contains the letter **M** or **W** denoting either wood or metal construction.

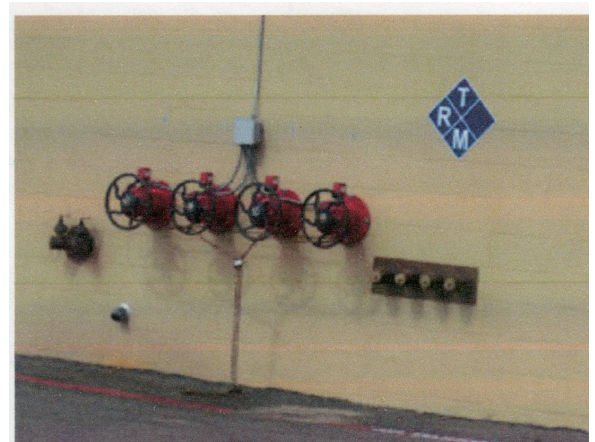
Blue Diamond signs are also located on the back sides of structures at FD connection.
